**Channels Residents
Community Group**

**Bellway Channels Residents
Estates Report
July 2018**

Bellway at Channels Estates Report

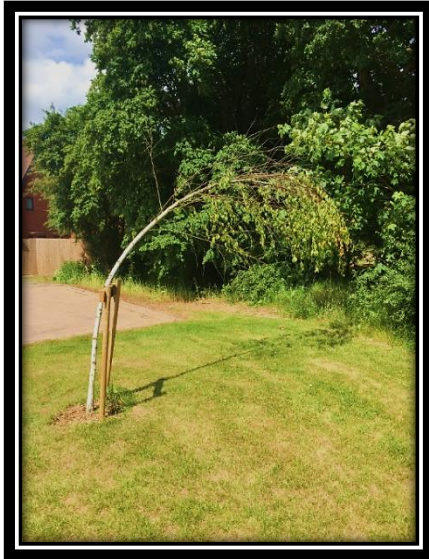
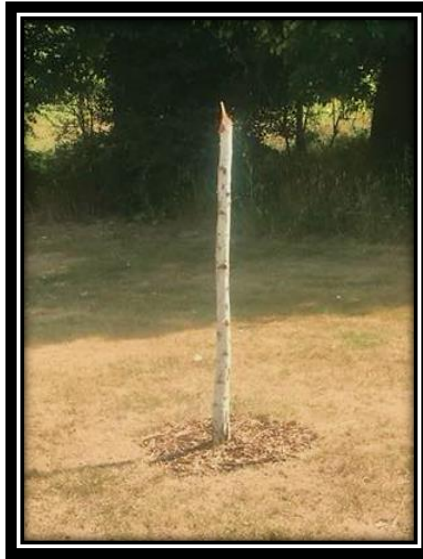
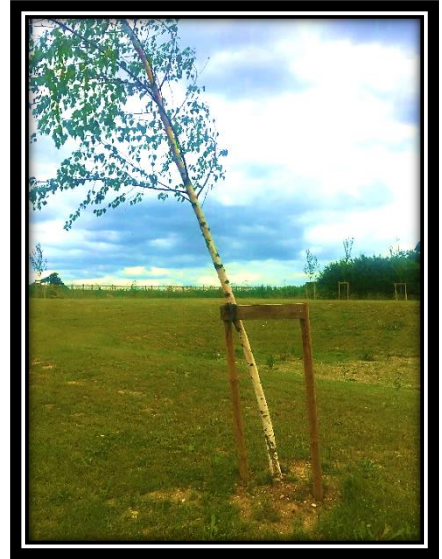
Trees – Niblick Green

The majority of the trees in this area are not planted straight, are insufficiently supported, are surrounded by weeds and are clearly not maintained. It is completely unacceptable that trees can be planted and left in such a fashion and the result of them eventually failing was inevitable. *Note: The left and centre examples are the same tree and the trunk finally snapped in late June 2018 with only the lower portion remaining.*

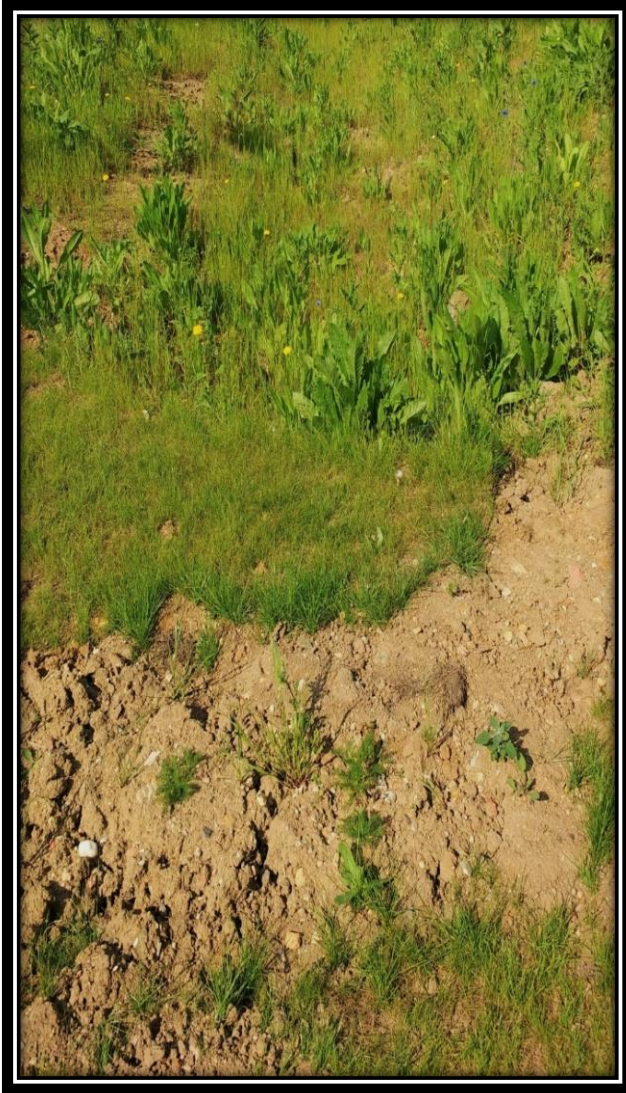
Unfinished Landscape Edges & Uncontrolled Weed Growth: Niblick Green

There are a number of swales throughout the development. The above examples are at Niblick Green and residents are aware that these must be maintained as wild flower meadows (as confirmed by the ecologist) and as such they will include some wild weeds.

However the unfinished and unsightly landscape edges have been left in a terrible state (including builders debris in places) with no care, attention or consideration for the environment being created for customers.

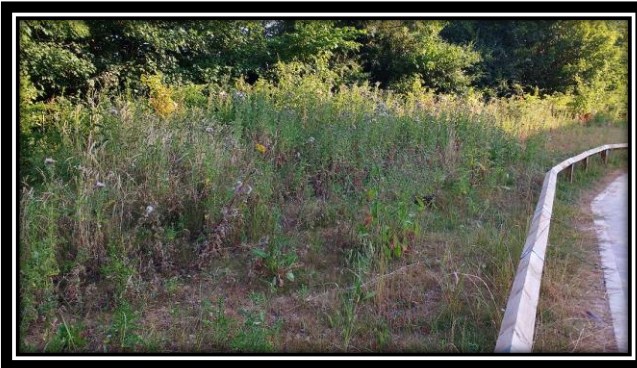
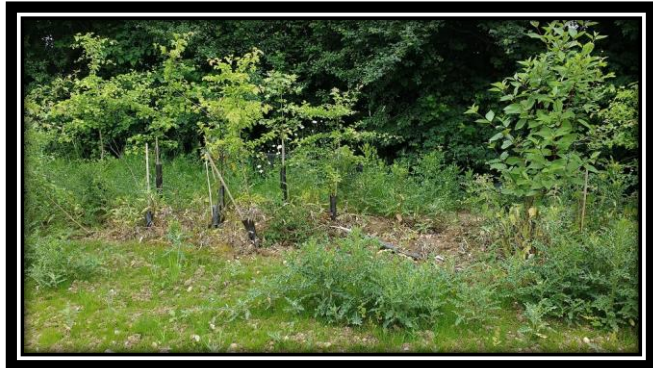
Unfinished Landscaping & Uncontrolled Weed Growth: Fairway Drive

The bank that backs onto the Bridle Path along Fairway Drive is supposed to be meadow grass with new trees planted to create hedgerow. This area has been left to become completely over run with thistle weeds which have prevented anything else from growing and it looks a complete mess. A number of the newly planted trees were knocked down during construction, many others have failed and there is builders debris mixed in with the earth. The landscape edge is uncontrolled and as such weeds and grass are encroaching onto the road.

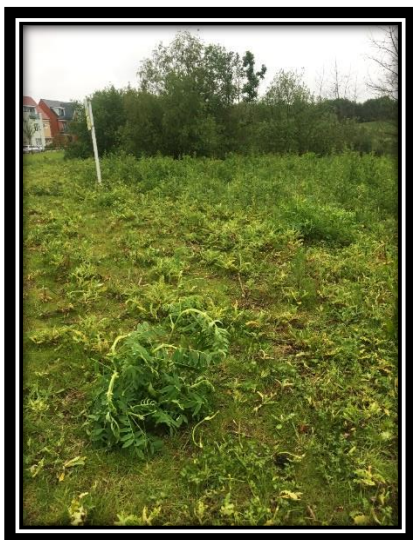
Example 1

It is clear that there has been a lack of care in relation to planting and maintenance, there is a lack of defined boundaries and the area has been left in a very poor condition. For example the grass seeding is sporadic at best and the area is full of aggressive weeds. It is not acceptable that the resident's estate management fee should be used to pay for the strimming of these weeds when they should have been removed properly at the outset and the land fully grass seeded prior to handover. Additionally it is not evident that any additional planting (in line with the aforementioned Acer Landscapes approved plan) has actually taken place.

It is also extremely alarming to see the amount of builder's debris which has just been abandoned on the site by Bellway including bricks, lumps of concrete, brick ties and until recently barbed wire. The area of open space is used by many residents including children and dog walkers and as such it has been left completely unfit for use and quite frankly an accident waiting to happen.

The landscaping in this entire area must be fully reviewed by Bellway to provide assurance that there has been no breach of their obligations in relation to planning approval and the issues noted above must be made good to ensure the area is fully fit for public use. Once all issues have been dealt with the area must be appropriately maintained by DJC Property Management.

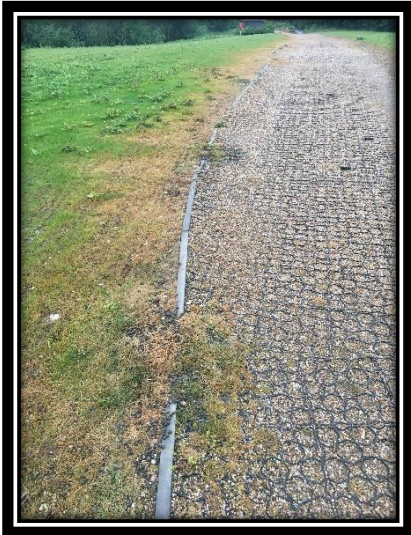
Example 4

As stated in the Acer Landscapes planting plan, the area was to receive “WG20 rich lawn meadow grass seed”. The examples above demonstrate what has been deemed acceptable by Bellway for handover and public use.

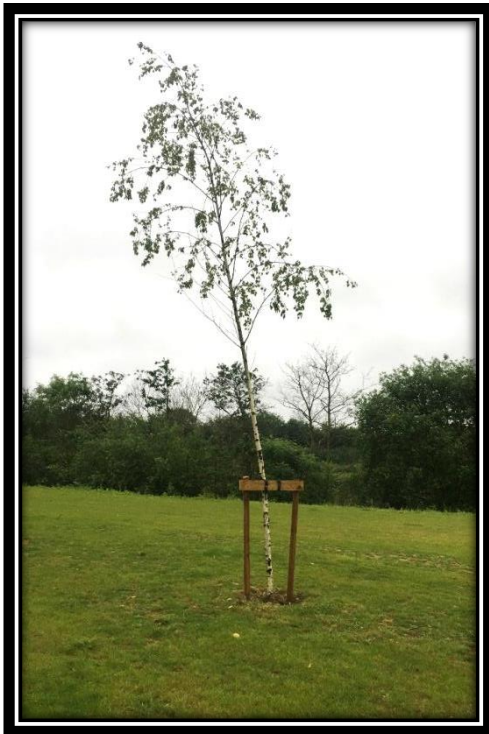
Bellway Channels Site Tree

There have been a number of trees planted and below left is a photo of one example. Alongside this is an example of how Croudace have planted their trees on the adjacent site. The clear (and quite frankly embarrassing for Bellway) differences are listed below. In addition we believe that 3 of the *new trees* planted in this area are already dead which further evidences the lack of attention or ongoing maintenance.

- The Croudace tree is planted straight whilst the Bellway tree is not and Acer have attempted to straighten at least 3 times unsuccessfully;
- The Croudace Tree pit is clearly edged and maintained whilst the Bellway pit is sporadically seeded and full of weeds;
- Croudace have added mulch to tree pit, Bellway have done nothing;
- The Croudace Tree has a neat timber tree support whilst Bellway added the horizontal element as an afterthought when tree was almost at 45 degrees;

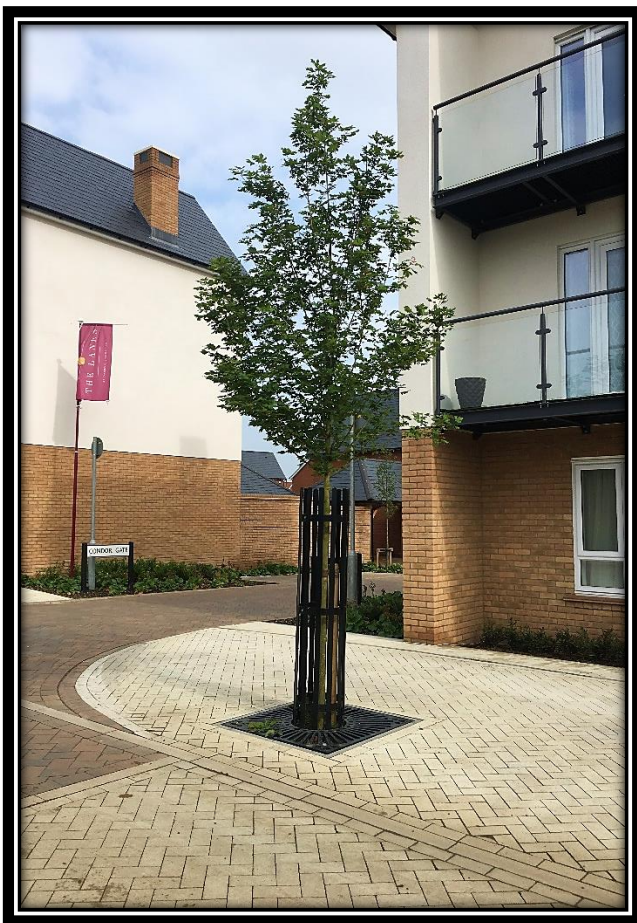
Croudace Street Trees – Example 1

The inconsistency and level of presentation in this regard is poor at best and the images below highlight how the “completed” roads on the adjacent **Croudace** site are finished in comparison to the Bellway site. As you will note a high level of care has been taken in presentation by Croudace, with colour and materials coordinated, and we would question why Bellway have not applied the same.

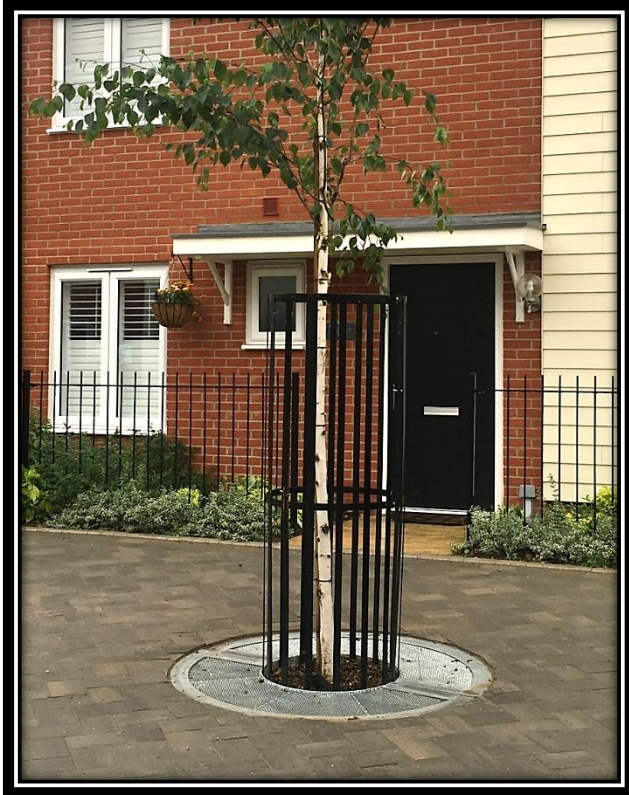
Bellway Street Trees (Fairway Drive) – Example 1

The example above shows a circular tree pit with an uncoordinated tree grill colour & poor installation which introduces potential Health & Safety trip hazards. Moreover this is unsightly and looks ill-considered.

It seems odd that the trees pits along the road are a different shape, one circular and the other 3 square. This looks like an error and something that has not been fully considered or coordinated during the design and construction process. Please note that the approved planning drawing on the portal by Robert Hutson Architects (reference 790-PL-33-E) indicates circular pits to all the trees.

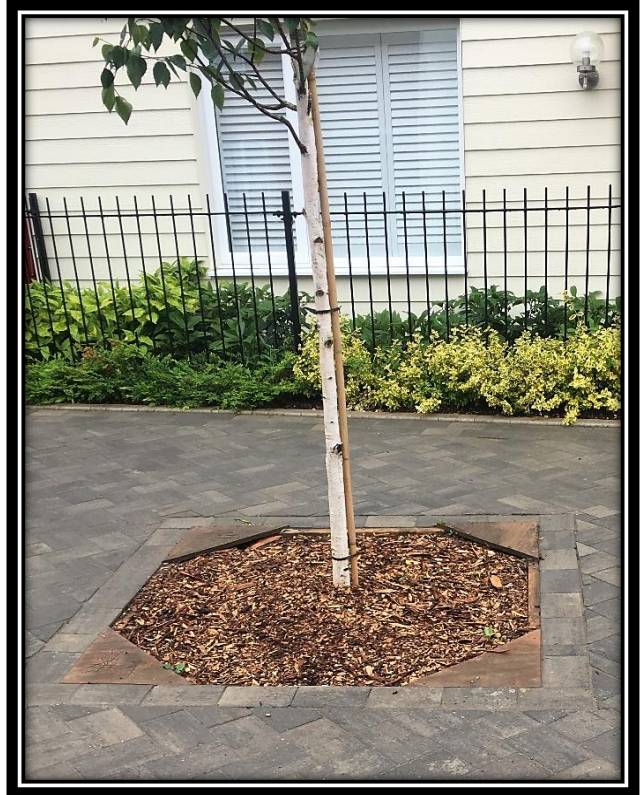
Bellway Street Trees (Fairway Drive) – Example 2

The example above shows a square tree pit, although the protection is missing completely. A timber insert is in place, which protrudes above the finished level of paving, creating a trip hazard. Consequently, this is being walked across, parked on and again looks poorly considered.

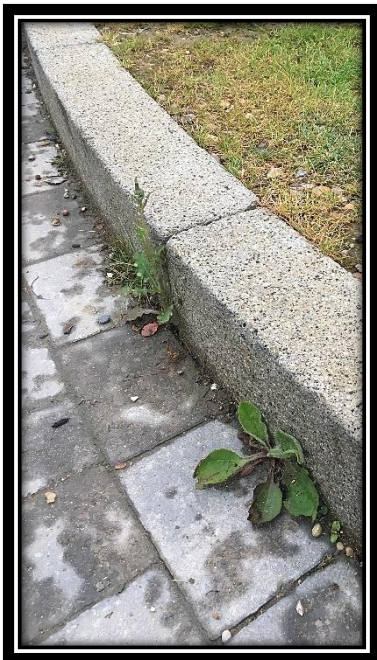
Weed Control - Example 1

The state of the roads (including dual use footpaths) is a major concern in terms of quality, general maintenance and indeed weed control. The examples below highlight the condition that the 'new' roads are currently in, and this situation is prevalent throughout the development.

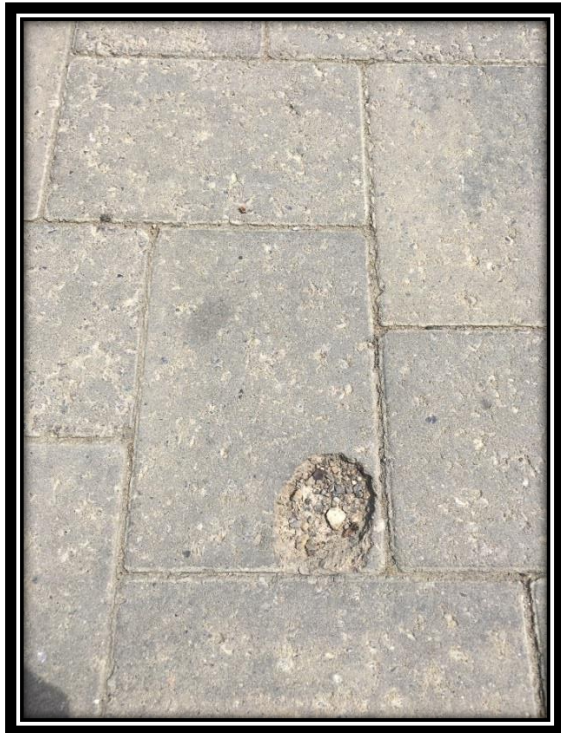
Damage to Block Paved Roads – Example 1

We also note that several of the roads throughout the development have been used as ‘haul roads’ for construction traffic access during the build process. Whilst we as residents reluctantly accept this, it is fair to say that roads have clearly been damaged by construction vehicles and as such all damage must be made good prior to Bellway leaving the site.

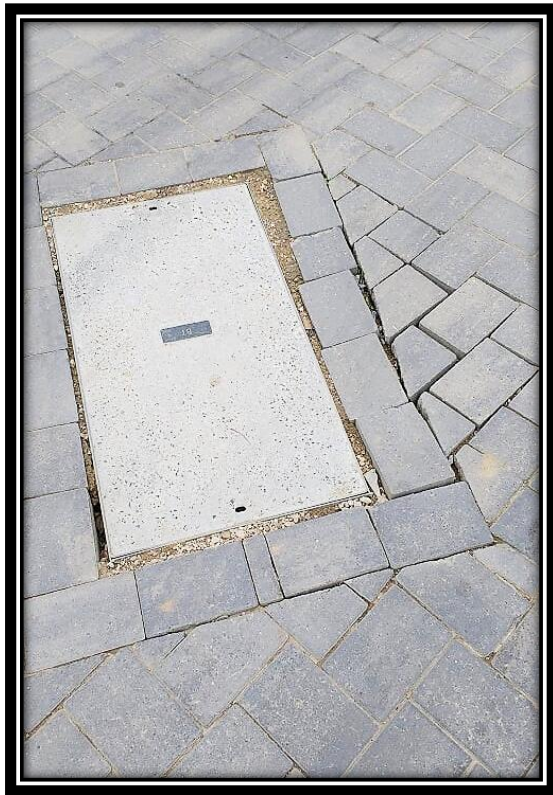
Finish of Block Paved Roads – Example 1

There are in addition many areas where the standard of installation and finish for block paved roads is not acceptable and there is a risk that highways may not accept them for adoption. The standard is truly shocking in some areas and can be seen throughout the development with the most recently laid areas of Fairway Drive providing many examples of uneven surfaces, dropped paving and gaps between blockwork. The resultant 'finished' roads are clearly the output of a job that has been rushed with complete lack of pride in the work.

BS 7533, Pavements constructed with clay, natural stone or concrete pavers refers to codes of practice. Indeed suppliers such as Marshalls suggest joints are to be "between 2mm-5mm". The examples around the site are numerous and far in excess of this, plus paving 'cuts' are of a very poor standard and therefore Bellway have fallen below minimum standards and codes of practice.

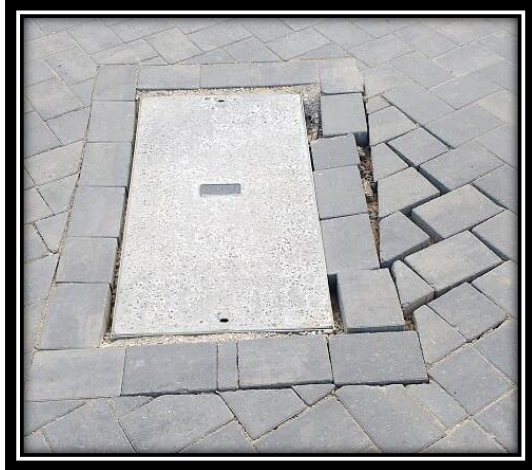
Finish of Block Paved Roads – Example 1a

The example on the left is the same location as shown in 'Example 1' above. The original image was captured at the beginning of June 2018 and the latest image was captured at the beginning of July 2018. There has been no adverse weather during this period.

Notwithstanding the poor quality of finish noted above, this example provides further evidence to support the lack of upkeep and maintenance generally around the development and on-going damage caused by construction traffic.

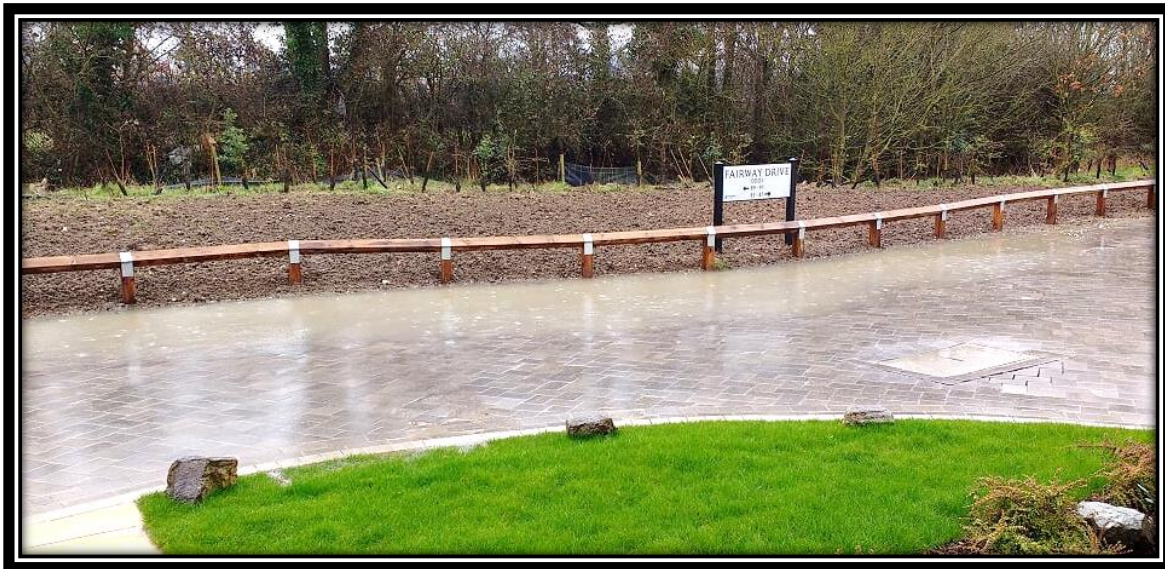
Roadway Flooding – Example 1a

There are also potential design flaws in the roadway design, the best example being at a junction on Fairway Drive where each section of road slopes to one central point. Even with a couple of hours of relatively light rain, water drains from each section of road and pools at the junction in addition to water draining from the bank behind. On a number of occasions the water has covered over half of the road and on one occasion was lapping at the front gardens of the two houses that sit on the junction. This has been reported to the Bellway Site Team by multiple residents on multiple occasions, by all accounts was a known flaw and yet to date (6 months after first reports), nothing has been done.

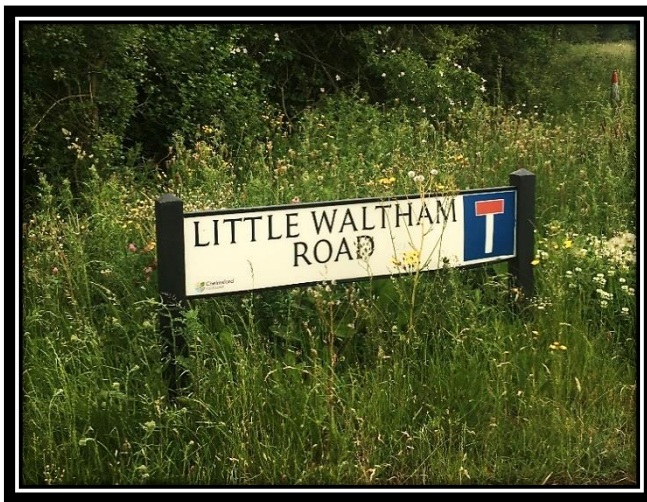
Street Signage – Example 1

Further to discussion with Chelmsford City Council, we understand that examples below are now standard fitting. We note that this has been incorporated where appropriate on *all* other new developments throughout the county and the examples below were taken from Broomfield & Little Waltham.

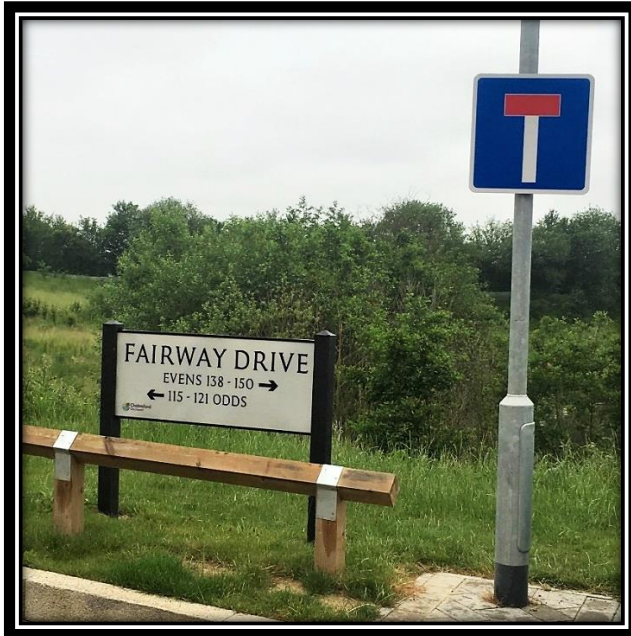
Bellway Street Signage – Example 1

The example on the left is a 'dead end' scenario in Fairway Drive without the appropriate signage.

The 'dead end' signage in this specific location was added retrospectively by Bellway after residents complained of visitors getting lost, delivery vehicles not finding addresses and emergency services actually having to stop and ask for directions.

The solution provided by Bellway is an afterthought and a throwback to the 1970's. Moreover, all dead end scenarios have not been addressed. This is unacceptable.

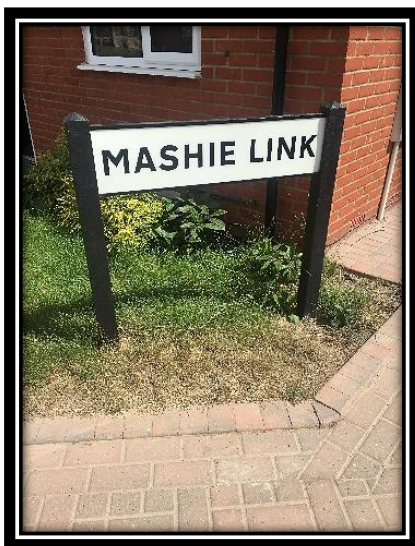
Bellway Street Signage – Example 2

The example on the left exhibits none of the requisite standardisation and even a different font type.

This further highlights inconsistencies and a general lack of care for the appearance of the development.

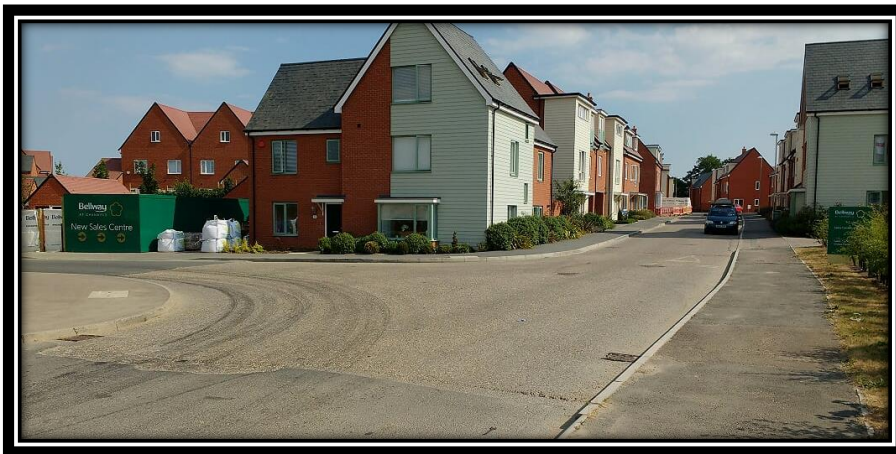
Lack of Road Marking/Signage

There is a complete lack of road markings or signage around the junction between Aqua Verde & Eagle Rise at the entrance to the estate which causes confusion and is potentially very dangerous. Whilst residents accept that the road is unfinished, the poor markings and lack of signage have been in the same state for 2 years which is unacceptable and we are aware that accidents have occurred.

Vehicles should indicate to turn right after entering the estate and wishing to proceed along Fairway Drive however the road looks as if the opposite is true i.e. the need to indicate left to proceed to Aqua Verde.

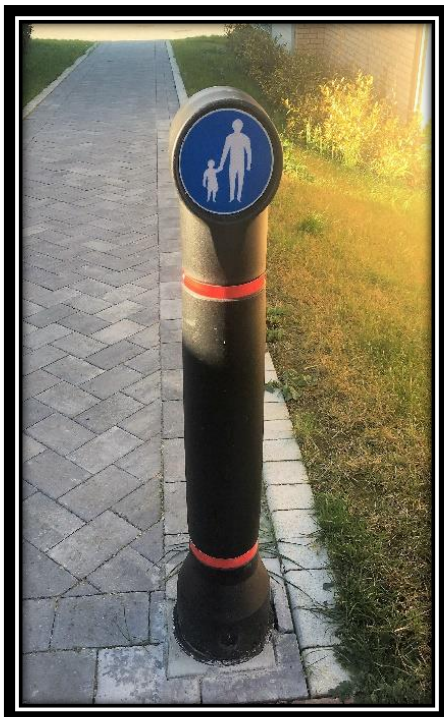
Bellway Street Furniture – Approved Bollard Design

BOLLARD DETAIL
(1:20)

Reflective signs are to be minimum
150mm deep

The example above represents an 'approved' design that Bellway were to incorporate across the development and which meets current Highway standards for bollards within a shared surface situation, i.e. no designated foot path and kerb, which is essentially the scenario we have at Fairway Drive.

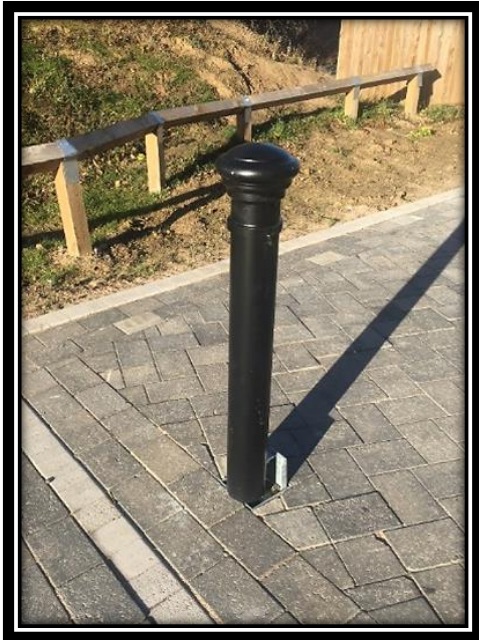
Bellway Street Furniture – Example 1

The above requirement is also reflected in the Essex design guide and as such residents would expect Bellway to adhere to the same standards throughout. However the bollards in place in Fairway Drive are *not* in line with the approved standard.

The examples above are only at Fairway Drive and are not as approved standards. Following complaints, reflective tape was added however even this has not been carried out properly.

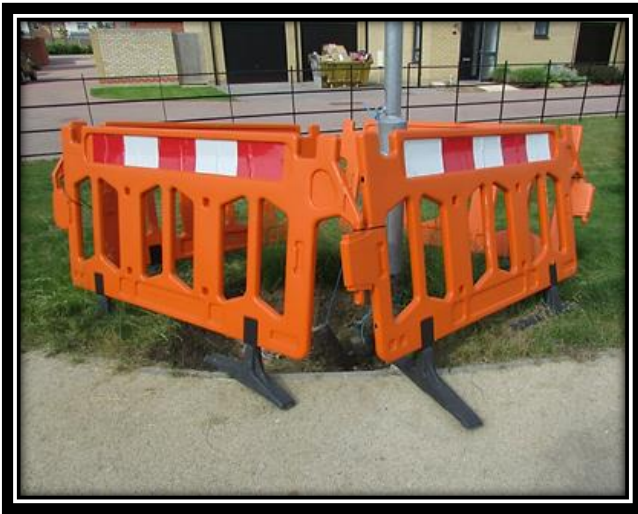
Unfinished Street Lighting – Example 1

There are several examples of street lights throughout the development (primarily in Niblick Green and the communal green area) which have never worked and are badly hoarded off. This has been the case for many months, the areas are a complete mess and ruin the look of the development.

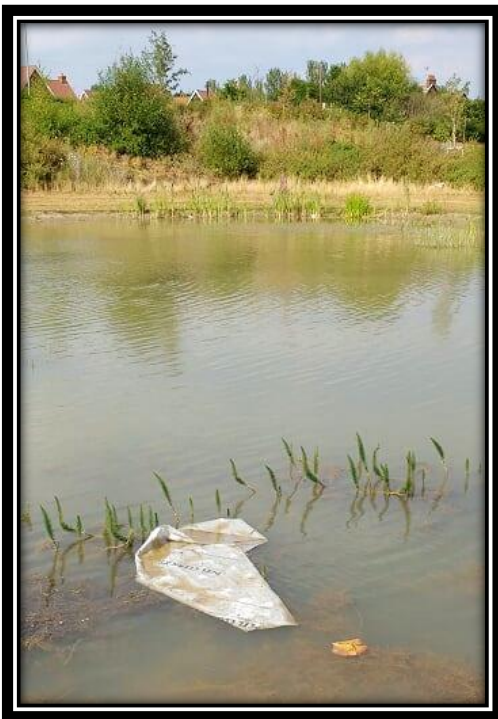
Builders Rubbish – Example 1a

The sight of builders debris and rubbish in areas of the development that should be kept tidy, especially as a number of them are stated to be ecological areas, is a frequent occurrence. During March, residents of Fairway Drive collected 2 large sacks of builders rubbish from the ecological area that backs onto the bridle path including paint pots, rags and empty cement bags which were entangled in the shrubs and trees. Most recently builders rubbish has been seen in the main lake at the entrance to the development, an area that this is specifically flagged as a key ecology area.

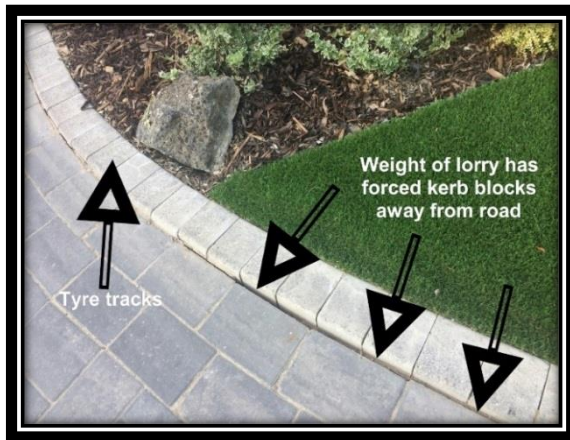
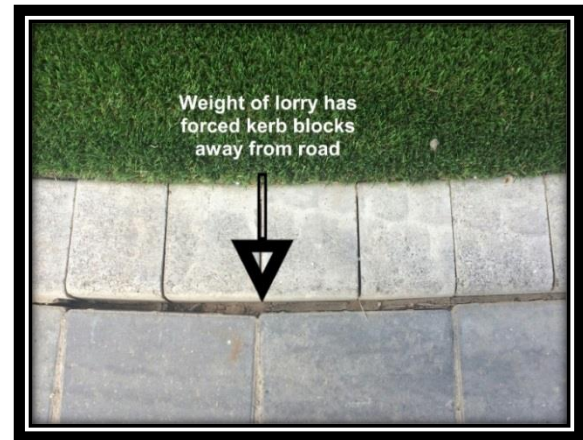
As a further example, on the afternoon of 4th July an extremely large tarmac lorry, for which the blocked paved roads are clearly not suitable or wide enough, caused damage to a resident's garden. There was no notification, no apology and in fact a response which implied it must have been non-construction traffic. This is yet another example of a total lack of care and attention, plus respect for your customers.
